***RIPARIAN AND WETLAND INVENTORY AND  
HEALTH ASSESSMENT ON ROBB CREEK AND  
LEDFORD CREEK IN THE ROBB/LEDFORD  
WILDLIFE MANAGEMENT AREA***

**January 2006**

**Bitterroot Restoration, Inc.**

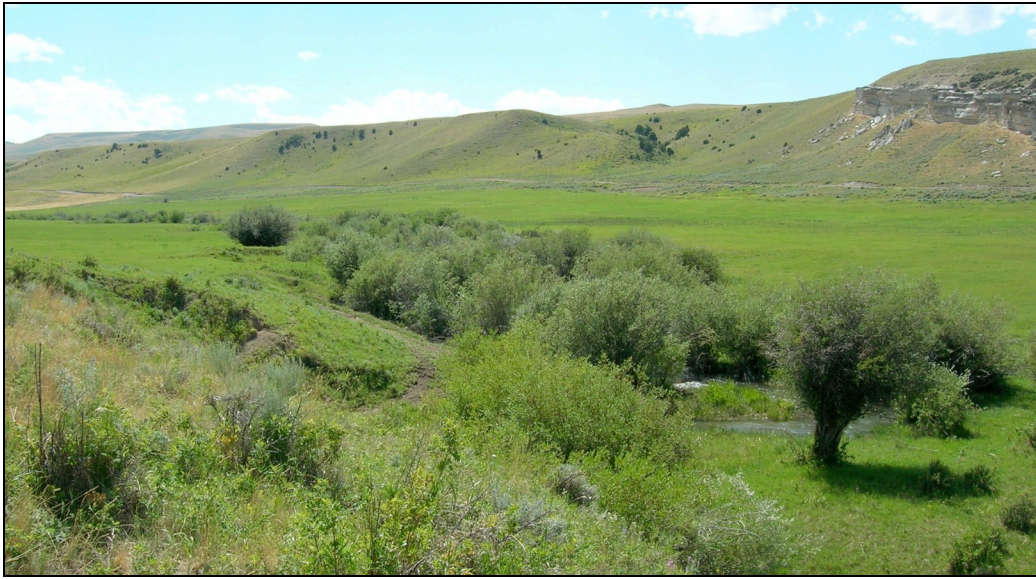
**Figure 3.** Overview of Ledford Creek showing riparian zone strip and wide, sub-irrigated pasture bottom

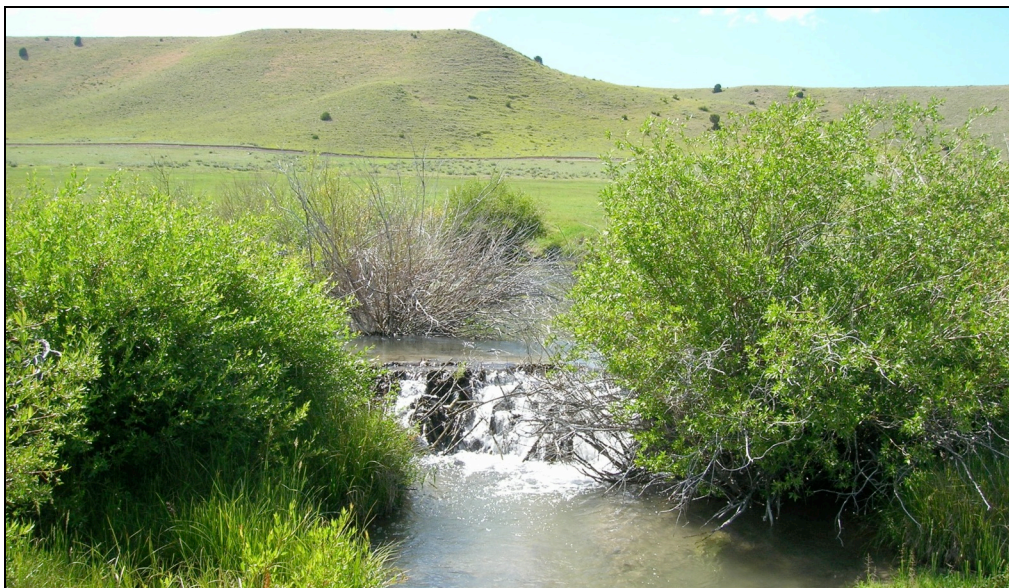
Although the same length of stream was inventoried (3.9 miles) again in 2005, the average riparian zone width was estimated much wider in this latter inventory. The riparian zone area included in all seven polygons on Ledford Creek was estimated in 1999 as 15.5 acres. The riparian zone area in 2005 was estimated at 48.3 acres. Although the estimation of width made in 1999 appears to have been low, certain kinds of riparian degradation can result in a narrowing of the riparian zone, and the healing process can widen it again. This process usually involves the lowering and raising again of the water table, so often with the help of beaver. That has been the case on Ledford Creek, where the average riparian zone width was 33 feet in 1999. In 2005 the average riparian zone width had increased to 102 feet, accompanied with a dramatic increase in active beaver presence (Figure 4).

**Figure 4.** Beaver dam on Ledford Creek in 2005 showing raised elevation of water level

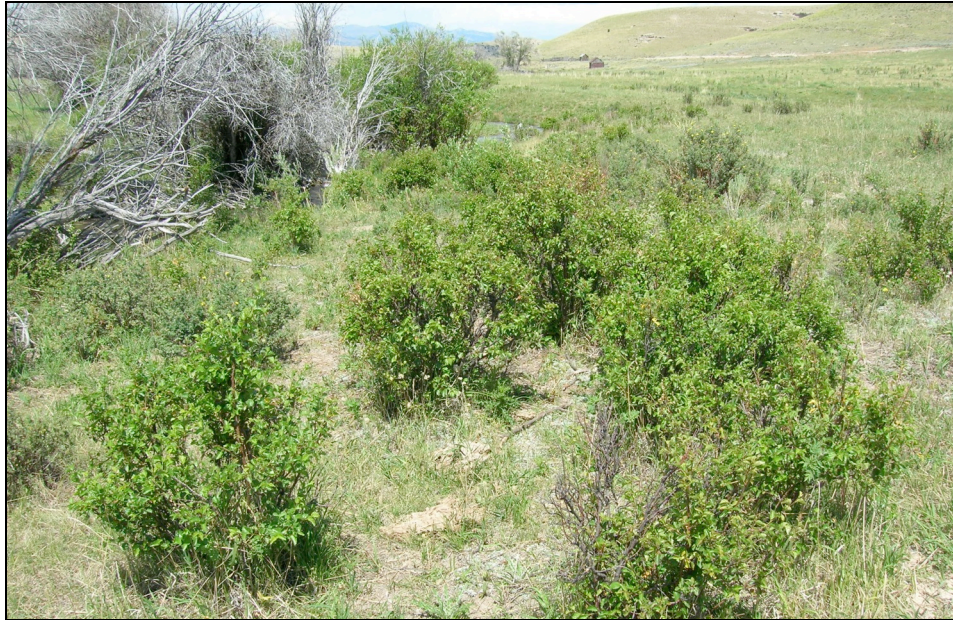
Browse utilization continues to be very heavy on all available shrubs. This condition is not much changed from 1999, when all accessible willow plants exhibited the “arrested growth type.” (Figure 5) No determination was made of whether browsing was being done by livestock or wildlife. It is likely that both are responsible.

**Figure 5.** Example of browsed shrubs on Ledford Creek in 2005 showing “arrested growth type”

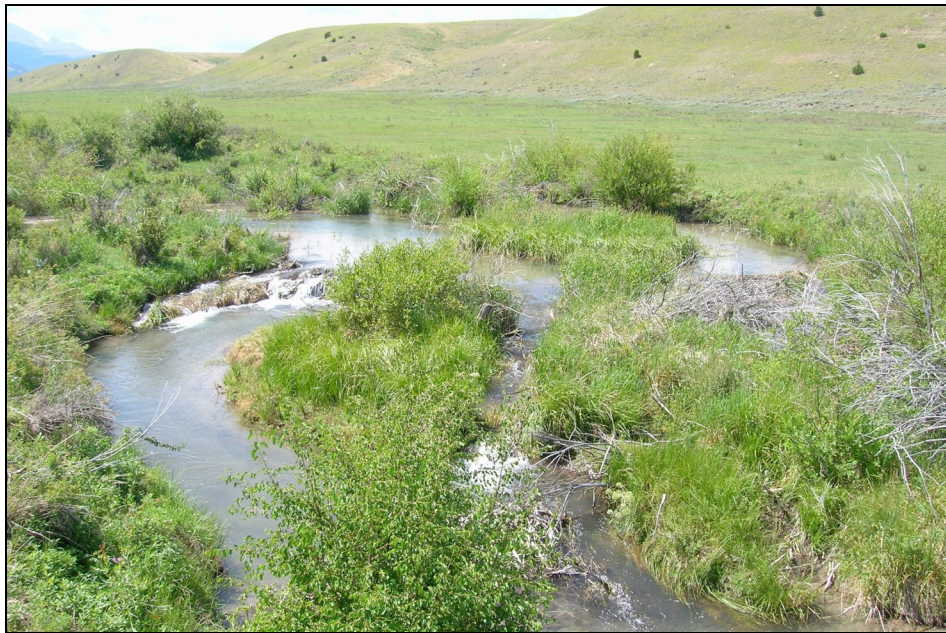
**Figure 6.** The stream scouring a deep channel through a failing beaver dam

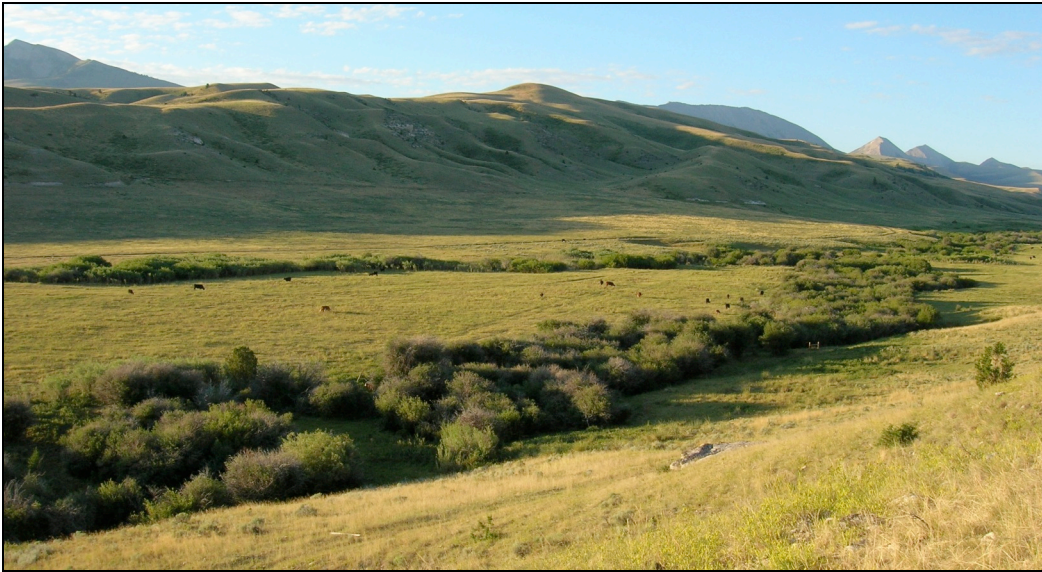
**Figure 8.** Overview of Robb Creek near the lower end showing split riparian community

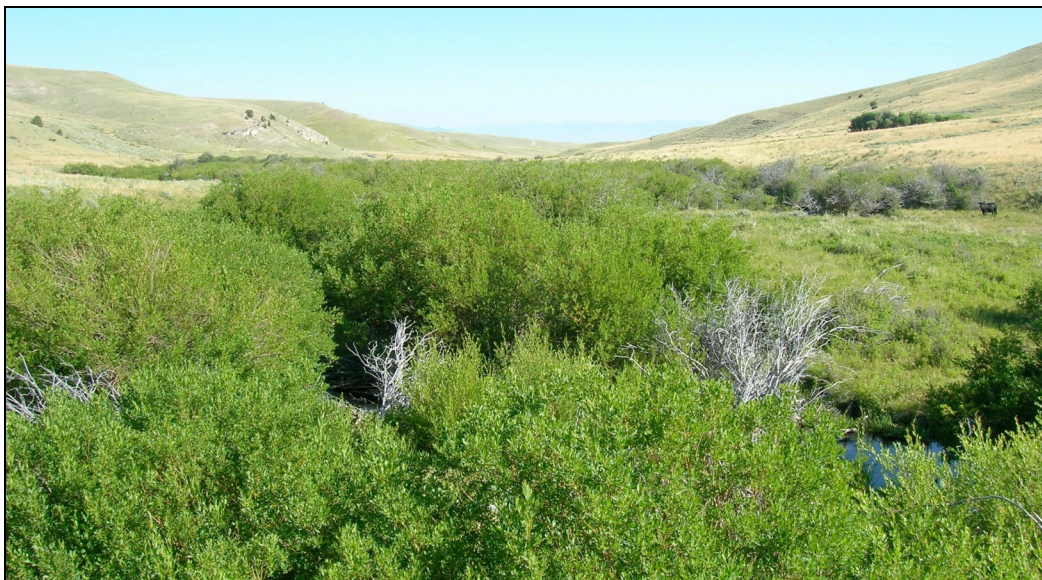
**Figure 9.** View of Robb Creek riparian zone near the upper end showing wide valley bottom

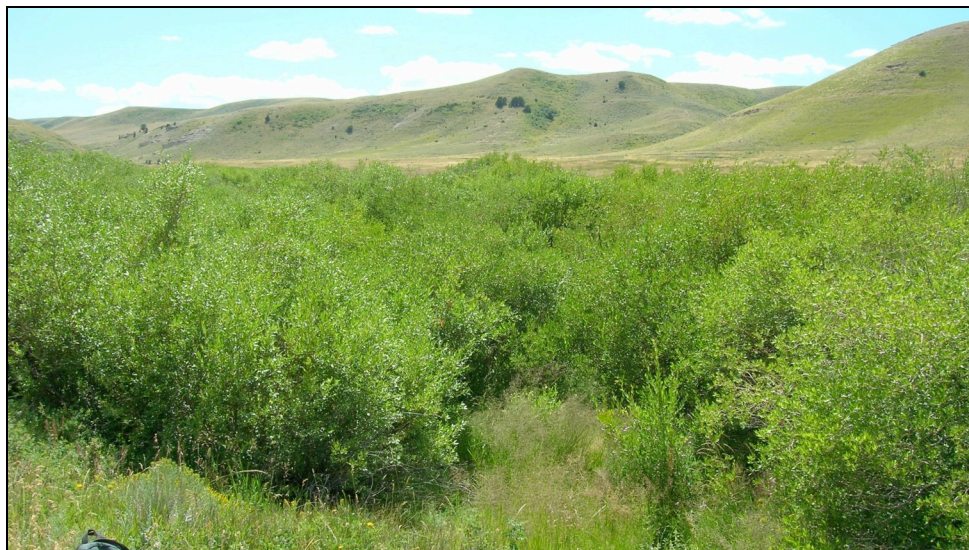
**Figure 10.** Lightly impacted willow community in polygon 3

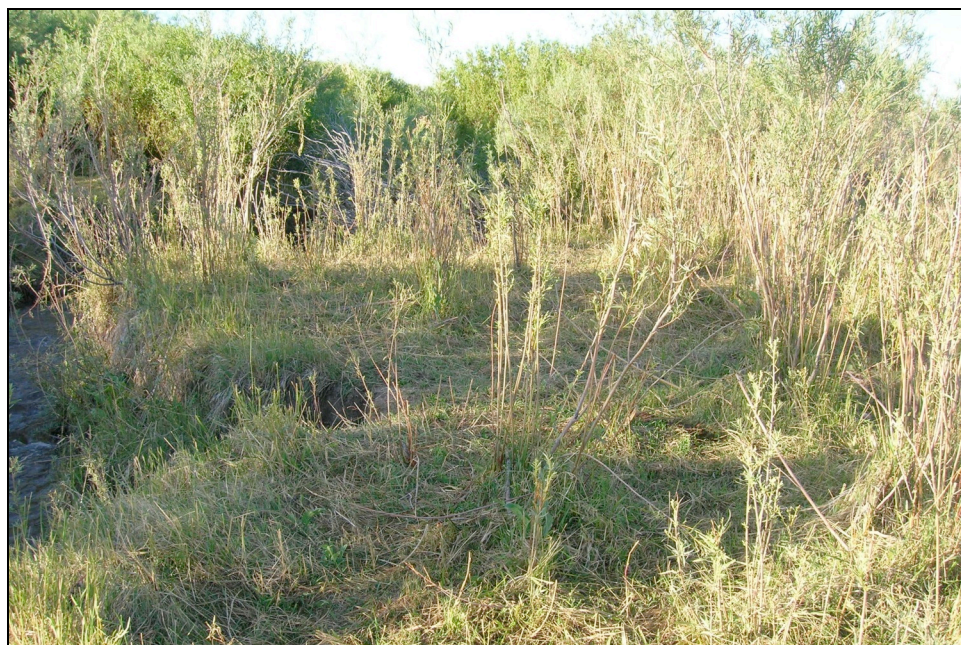
The level of shrub browse utilization was unevenly distributed in the same pattern as general forage use. The middle polygons (3, 4, and 5) have recently been used lightly, or not at all, while on the upper end (polygons 1 and 2) and the lowest polygon (number 6) utilization was heavy. The willows exhibited “uninterrupted growth type” only on sites inaccessible to livestock and “released growth type” on much of the middle three polygons. On the more accessible sites most willow plants have “arrested growth type.” Figure 10 shows a willow community in the recently unimpacted polygon 3. Figure 11 shows heavily browsed and trampled willows in polygon 6.

**Figure 11.** Heavily impacted willows in polygon 6

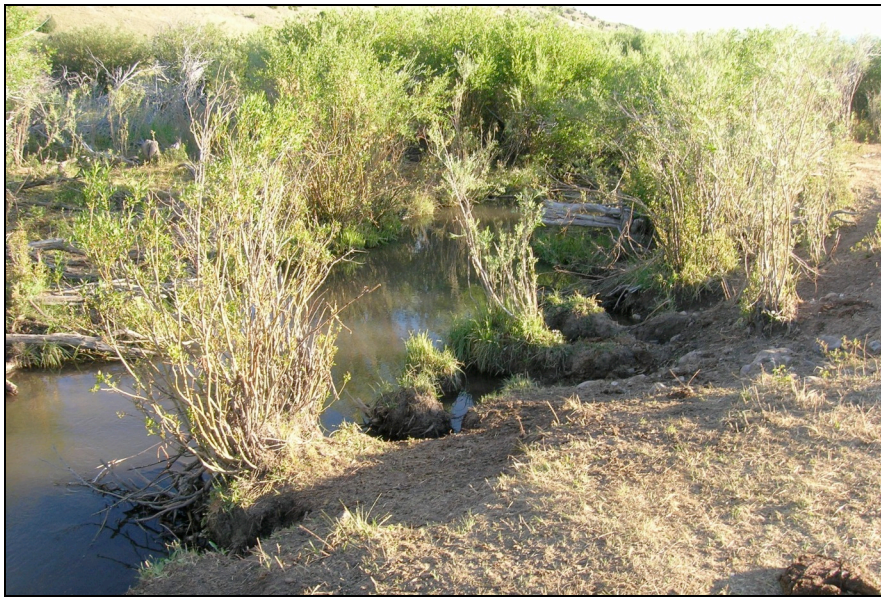
**Figure 12.** Human caused alteration in and along the channel of Robb Creek in polygon 6

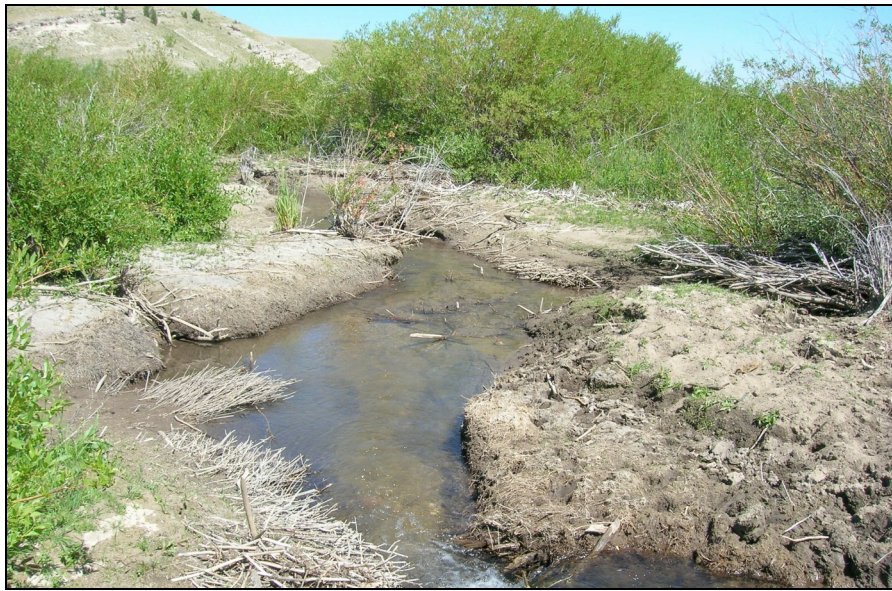
**Figure 13.** Early stages of incisement of blown beaver dam in polygon 6

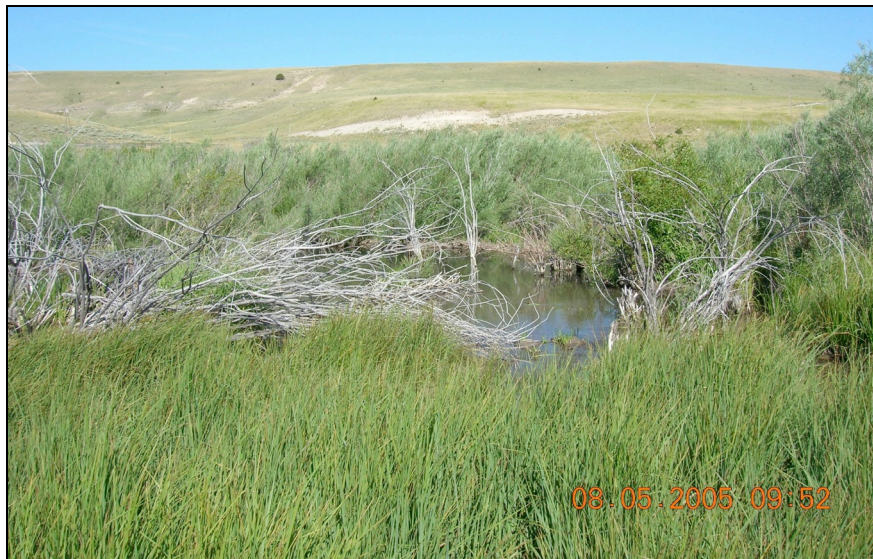
**Figure 14.** Lush sedge and willow production due to beaver maintained high water table
